Bridge Defects

Concrete Defects

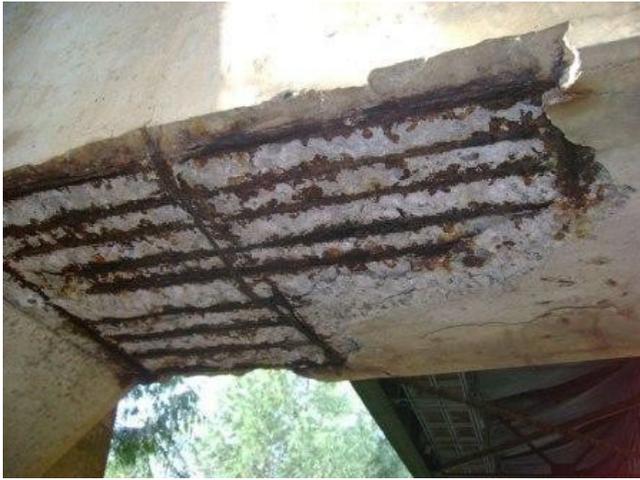
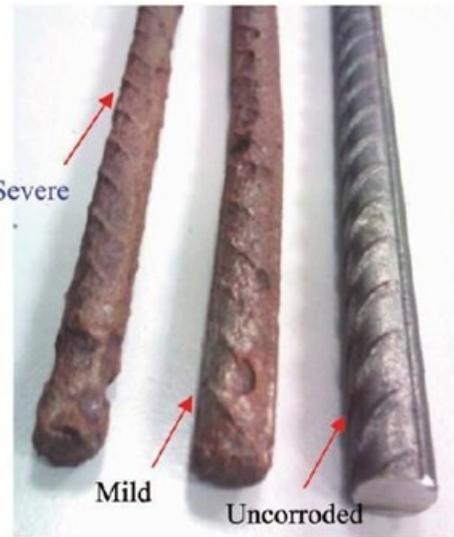
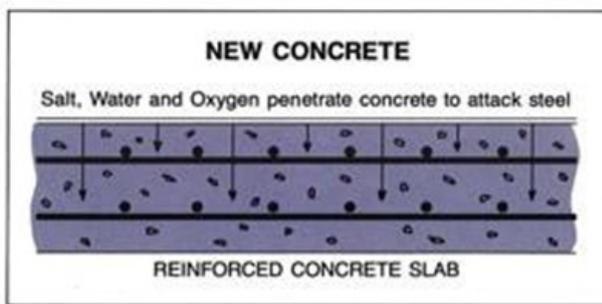
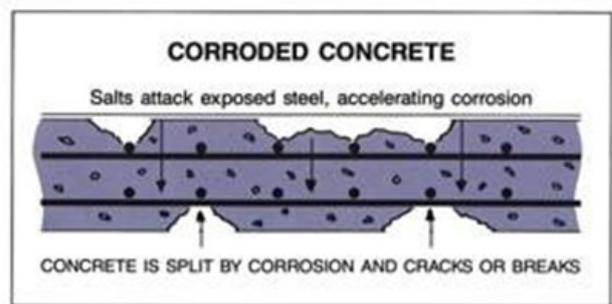
Corrosion of Reinforcement or Tendons

since concrete is poor in providing resistance to tension, most designs essentially ignore the contributions of concrete in the tension regions of the load-transfer mechanisms, making the reinforcement the critical member in these sections. Therefore, any significant loss of a section of the reinforcement or tendon due to corrosion would significantly reduce the load-carrying capacity of the member.

Concrete provides protection to the reinforcement or tendon and maintains a good alkaline environment of about pH 13, which leaves the reinforcement in a passive state. When this alkalinity is compromised and drops below pH 10 through exposure to salt, oxygen, moisture, air or other chemicals, the process of corrosion is triggered and can accelerate fast.

The bridge inspection exercise, therefore, should diligently seek for any exposed reinforcement or tendon or for defects that would expose them to environmental conditions and thus exacerbate corrosion.

Measurement – condition assessment should include extensive sketches of defects, including some level of quantification (say length, area, percentages measures) and determination of the degree of reinforcement section loss when corrosion is already in progress.

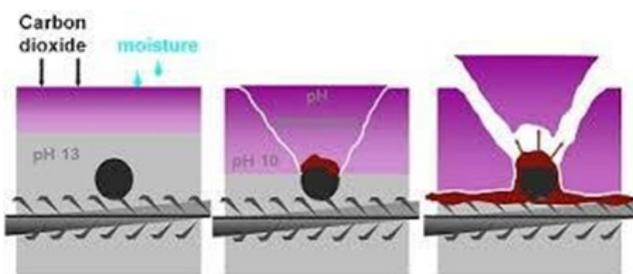
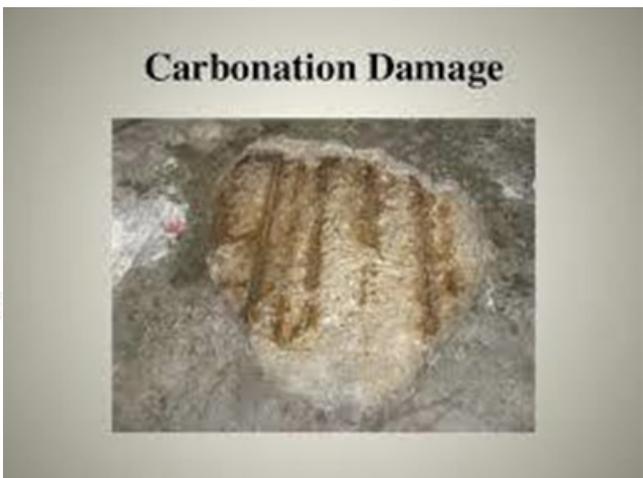
Carbonation of Concrete

This chemical condition affects the durability of concrete and lowers the alkalinity of the concrete cover to the reinforcement. The expansion of the carbonate gel that results from the chemical reaction may produce cracks in the concrete, thus opening a fault line for further progression of carbonation, and consequently causing the reinforcement to become prone to corrosion. Carbonation does not actually harm the concrete directly nor reduce its strength. However, poor, and porous concrete with high permeability, high water-to-cement ratio, low cement content, short curing period, or poor consolidation makes the concrete susceptible. Its resulting effects on the concrete allow corrosion of the reinforcing steel to thrive.

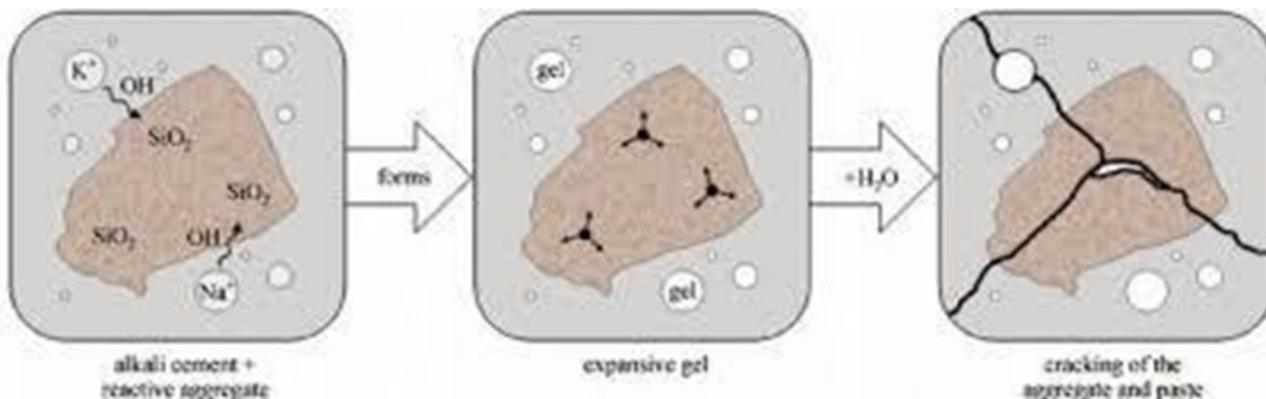
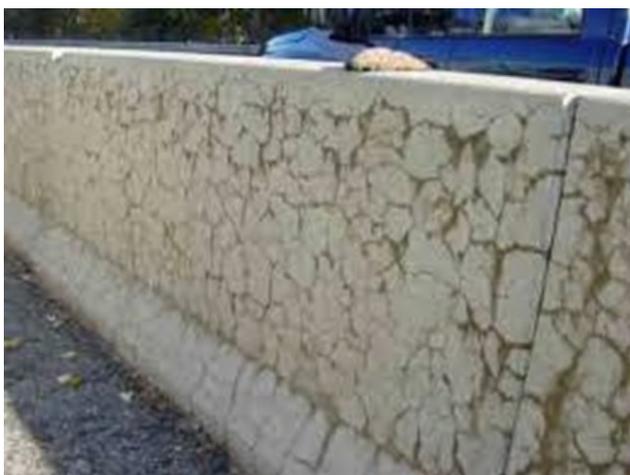
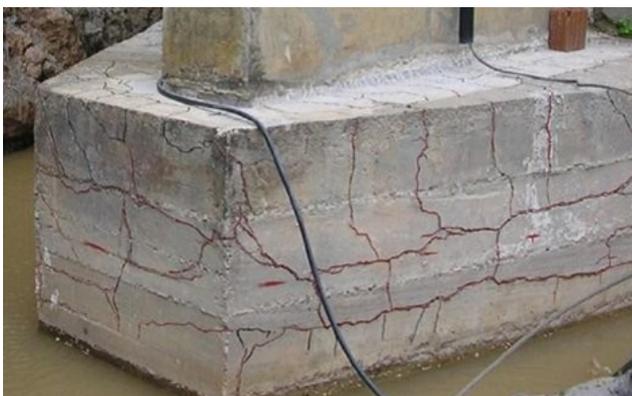
Alkali-Silica Reaction

This chemical attack on concrete durability is as a result of the reaction of the silica in certain aggregate types with

the alkaline in cement to produce Alkali-Silica Gel. The expansion of the gel when mixed with moisture leads to cracking and delamination of concrete. Its effect may take about 5 to 10 years to appear.

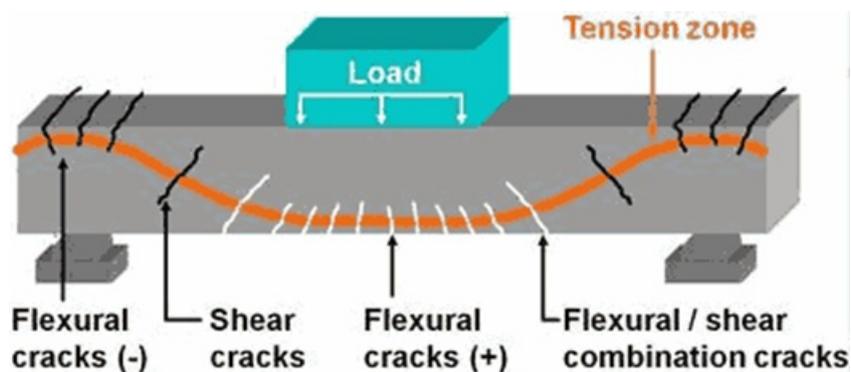
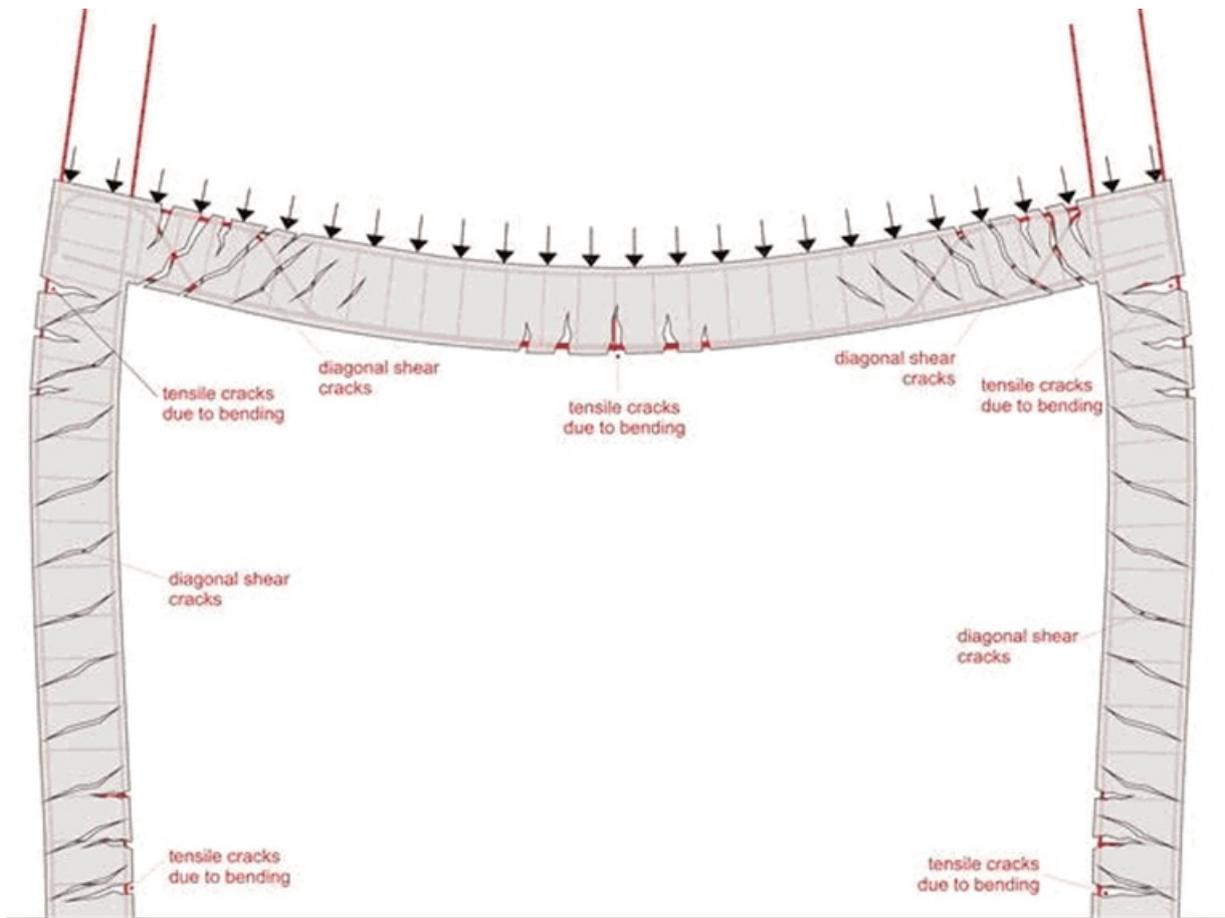
Cracks in concrete

So far, we have seen concrete cracks initiated by environmental conditions resulting in chemical reactions that lead to cracking of concrete. In addition to these, a concrete member can also crack due to overload situations while performing its structural functions. These cracks again expose the reinforcement to corrosion agents and should be eliminated.

The extent of the crack width measurements can be assessed against a scale such as shown below:

Type of crack	Crack Opening or crack width
Hairline cracks	up to 0.1mm
Minor cracks	0.1 to 0.3mm
Moderate cracks	0.3 to 0.6mm
Severe cracks	> 0.6mm

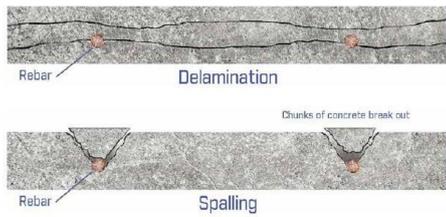
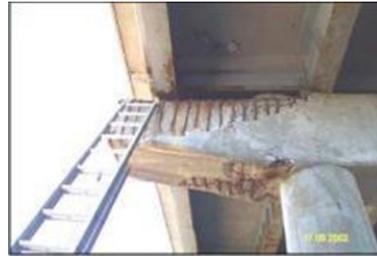
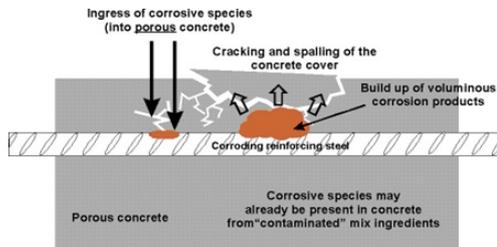
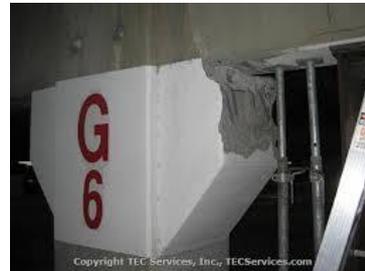
Spalling of Concrete

This can be as a result of the chemical attacks previously mentioned. It can also be due to the expansive action of corroded reinforcement exposed from flexural or shear cracks that develop on the member as a result of overload or due to damage by vehicular or vessel impact forces usually at the exposed corners or edges, deck joints or construction joints. In all cases, spalling is characterized by the actual removal or detachment of chunks of the concrete member. Therefore, there is an appreciable loss of concrete section that must be noted and recorded.

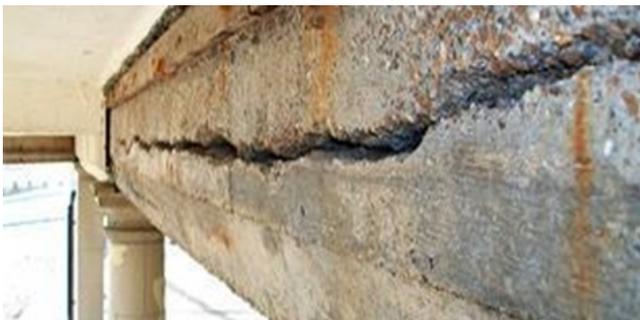
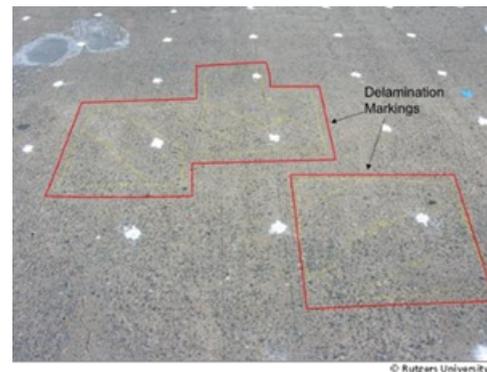
Delamination of concrete

This is a discontinuity in the surface concrete that is substantially separated but not completely detached from the concrete below or above it. It may appear as a solid surface but can be identified by a hollow sound that is produced by tapping the concrete with a hammer. Delamination defects may be hard to detect in the field and should be assessed very carefully.

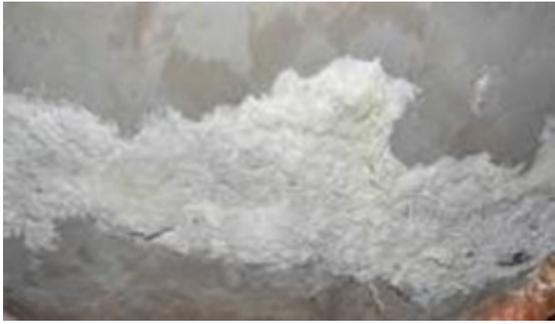
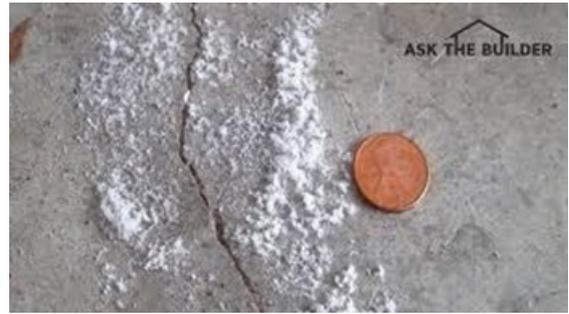
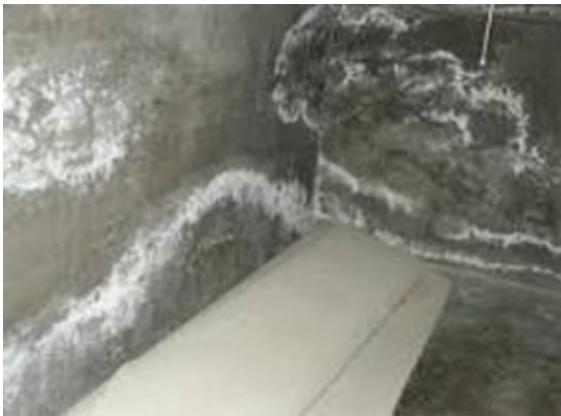
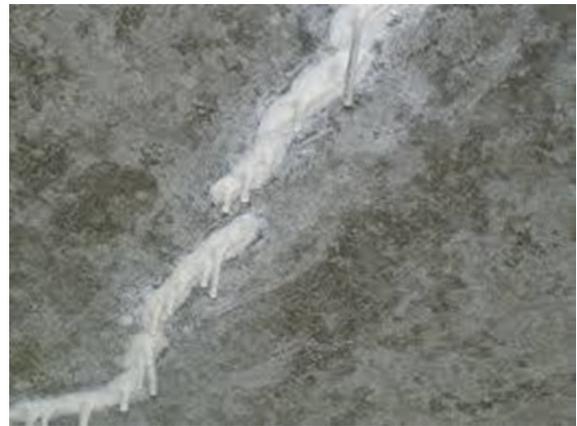
Surface defects in concrete

A surface defect is not necessarily serious in itself, but is indicative of a potential weakness in concrete and needs to be captured during the inspection. Such defects may very well have serious traffic or bridge safety consequences if not treated. There are a few concrete defects under this category and they include:

- Concrete Segregation – due to the differential concentration of the components of mixed concrete.
- Cold joints – produced when there is a delay in the placement of successive pours of concrete.
- Surface Deposits:
 - Efflorescence – deposit of salts, usually white and powdery, resulting from a mixture of salt and water that oozes out to the surface through pores or cracks in the concrete.

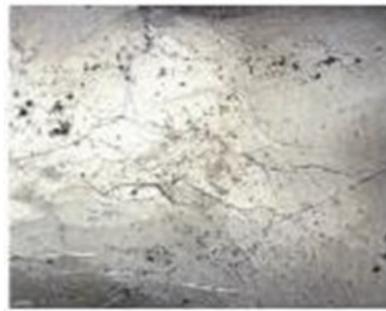
- Exudation – Liquid or gel-like discharge through pores and cracks in the surface.
- Encrustation – A hard crust or coating formed on the concrete surface.

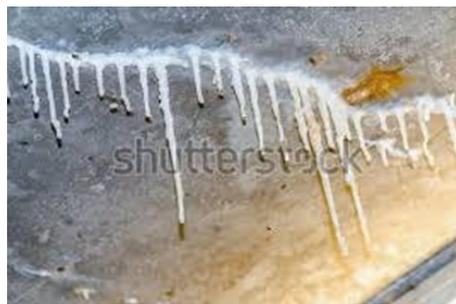
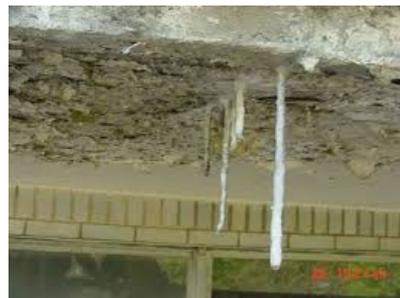
- Stalactite – A downward pointing formation hanging from the concrete surface, usually shaped like an icicle.

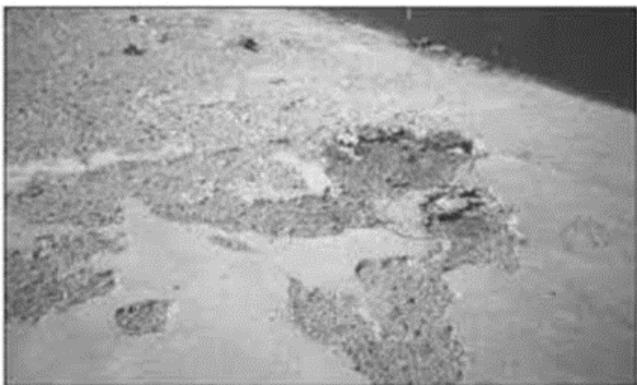
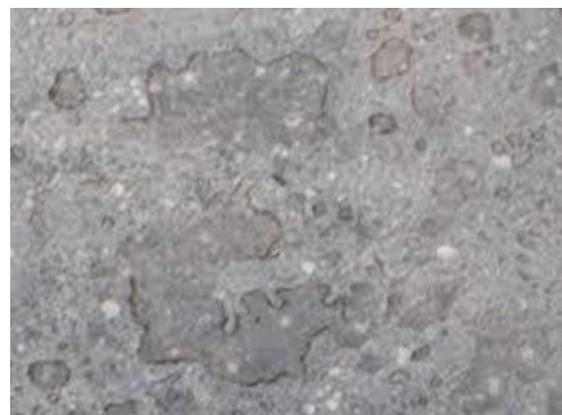
Abrasion

Deterioration of concrete brought about by vehicles scraping against the concrete surfaces, such as the deck, Kerbs, barrier walls, and Piers.

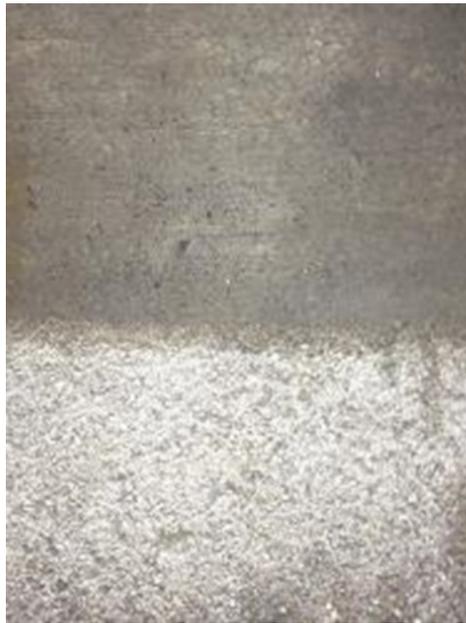
Slippery surface

Results from the polishing of the Conc. Deck surface by the action of repetitive vehicular traffic.

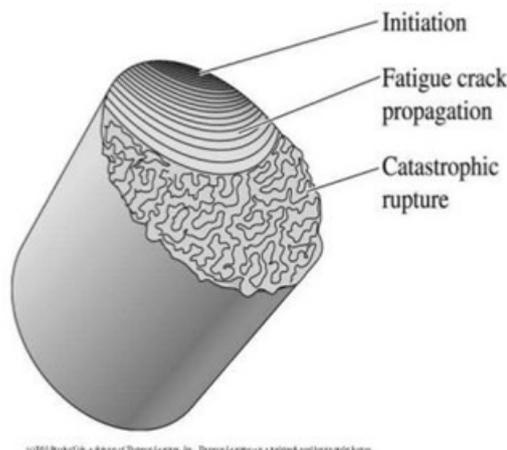
Figure : Schematic representation of a fatigue fracture surface in a steel shaft, showing the initiation region, the propagation of fatigue crack (with beam markings), and catastrophic rupture when the crack length exceeds a critical value at the applied stress

Note: Cracks perpendicular to the direction of stress are very serious, with those parallel being less so, but can still turn into perpendicular as they run unchecked.

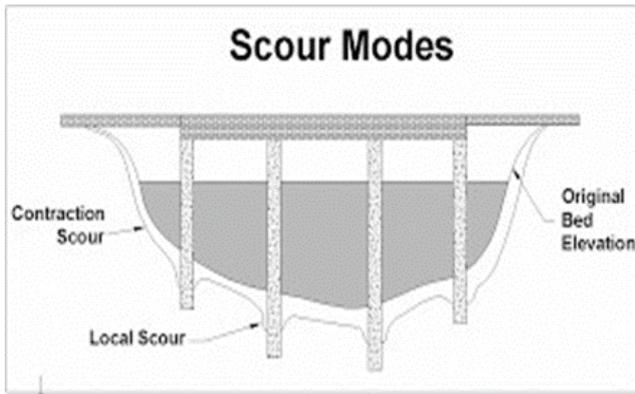
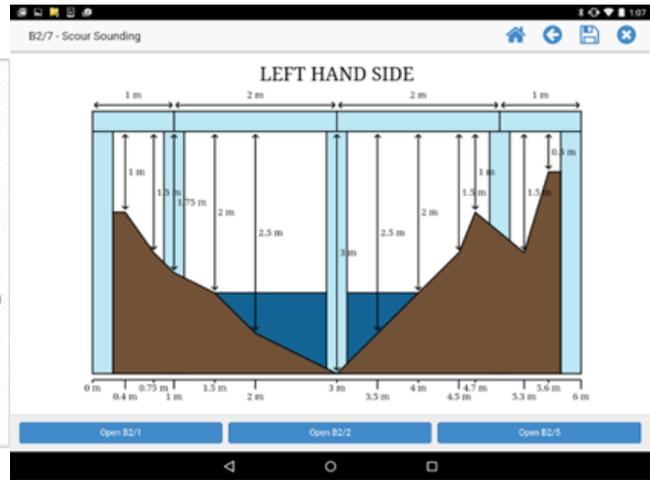
Scouring of Foundation

Scouring of foundation caused by excessive stream flows or changes in the alignment of the stream channel can result in the progressive settlement or movement of abutments and piers and consequently to total bridge collapse if unchecked. Scour is perhaps the biggest threat to the substructure and foundation components regardless of the material the structural component is made of. Exposure of the foundation components and erosion of the surrounding soil strata is a recipe for disaster and poses a serious safety hazard to the structural integrity of the bridge and must be avoided or corrected immediately.

Scour Modes are in three main forms:

1. **General Scour** – occurs naturally in stream channels and includes the aggradation and degradation of the stream bed, which may occur as a result of changes in the hydraulic parameters governing the channel form such as changes in the flow rate or changes in the quantity of sediment in the river channel.
2. **Contraction Scour** – occurs as a result of the reduction in the channel's cross-sectional area that arises due to the construction of structures such as bridge piers and abutments. It manifests as an increase in flow velocity and the resulting bed shear stresses, thus causing scour.
3. **Local Scour** – occurs around individual bridge piers and abutments.

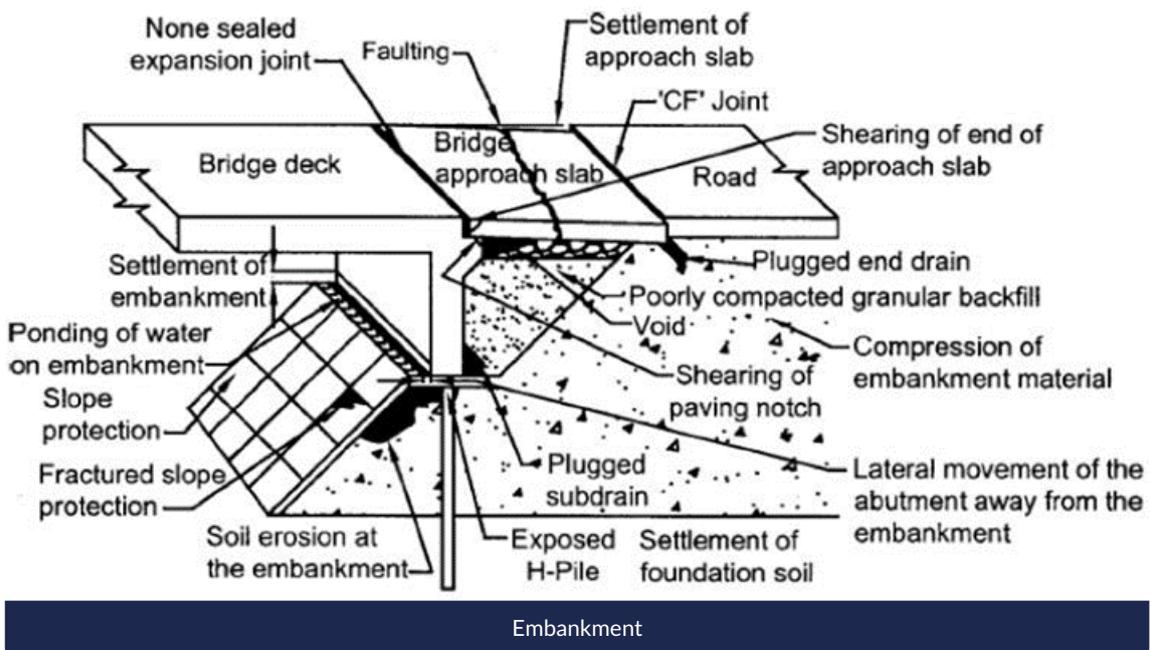
Conditions at the Approach

An Embankment is used to provide a stable road between the bridge and the surrounding ground. Often, it is also required for providing horizontal, and sometimes vertical support for the Abutment and foundation. The most common defect associated with the Approach is excessive settlement adjacent to the bridge abutment, which causes unsatisfactory riding quality and possible damage to the deck and expansion joints. Excessive settlement at the bridge approach span interface with the main bridge structure resulting in a “bump” is a safety hazard for the vehicular traffic and its users. Possible reasons for this failure include:

- Poorly compacted embankment
- Continuing settlement of the underlying ground
- Erosion due to blockage or inadequate drainage

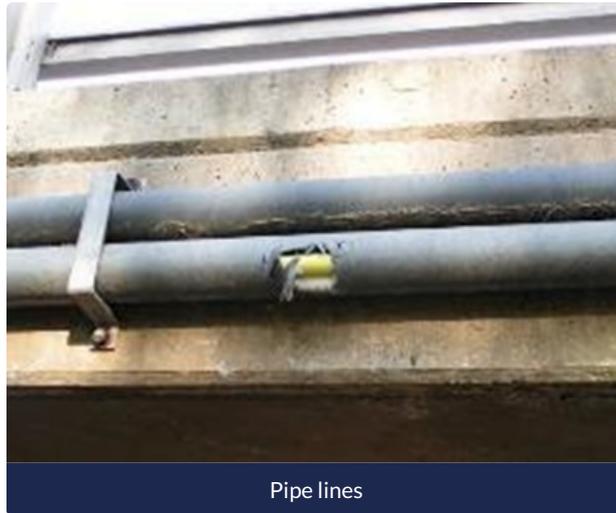
Utilities, including Lightings and Pipe lines, are often found on bridges and must be inspected for their functional integrity, especially with respect to the bridge structure.
