Bridge Defects

Concrete Defects

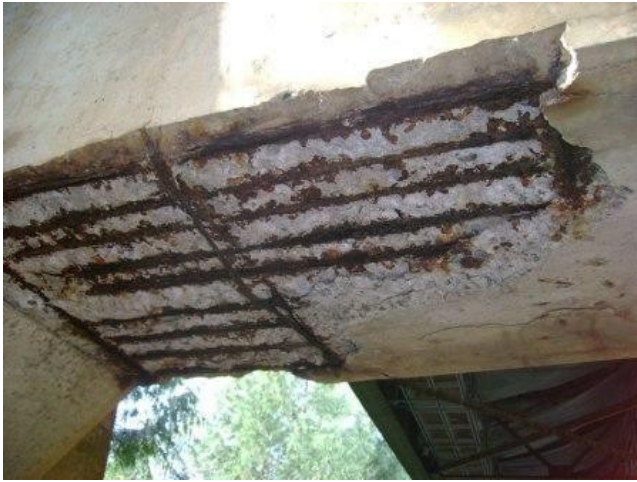
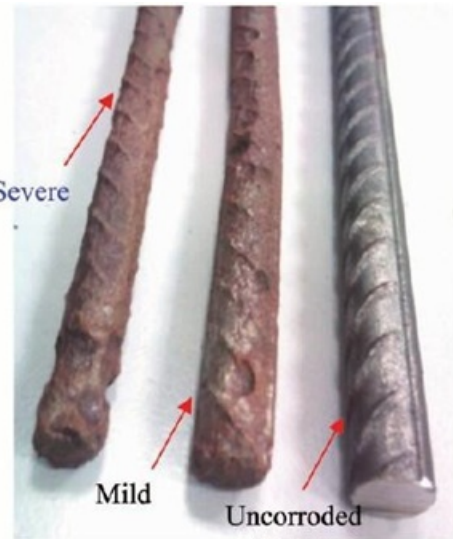
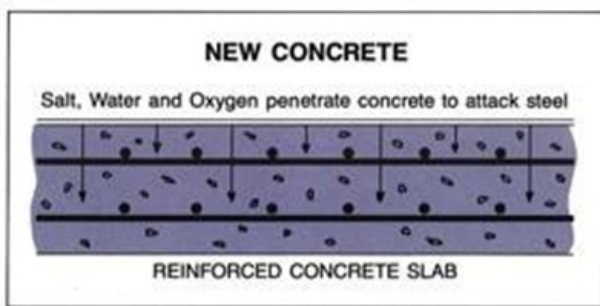
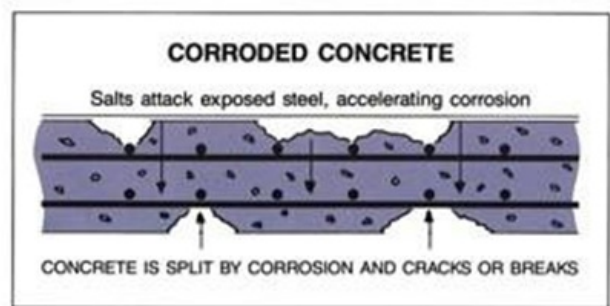
Corrosion of Reinforcement or Tendons

Since concrete is poor in providing resistance to tension, most designs essentially ignore the contributions of concrete in the tension regions of the load-transfer mechanisms, making the reinforcement the critical member in these sections. Therefore, any significant loss of a section of the reinforcement or tendon due to corrosion would significantly reduce the load-carrying capacity of the member.

Concrete provides protection to the reinforcement or tendon and maintains a good alkaline environment of about pH 13, which leaves the reinforcement in a passive state. When this alkalinity is compromised and drops below pH 10 through exposure to salt, oxygen, moisture, air or other chemicals, the process of corrosion is triggered and can accelerate fast.

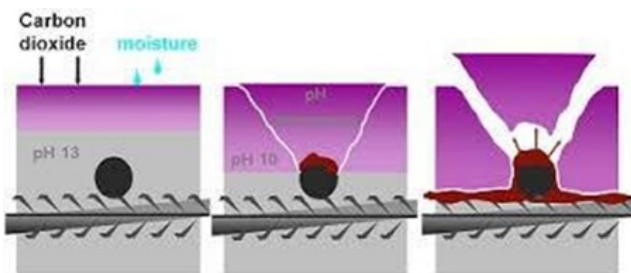
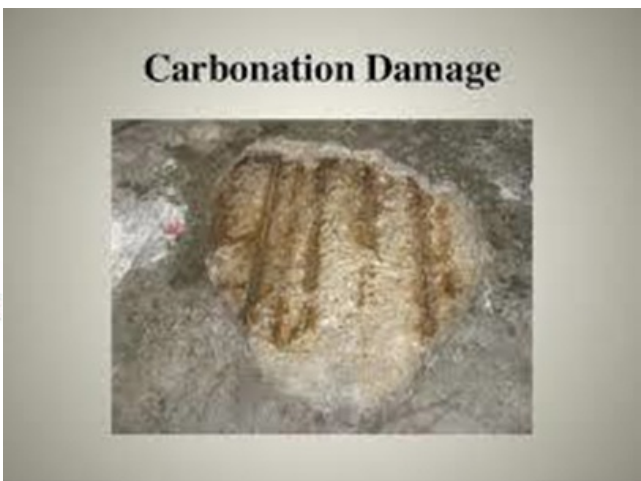
Carbonation of Concrete

This chemical condition affects the durability of concrete and lowers the alkalinity of the concrete cover to the reinforcement. The expansion of the carbonate gel that results from the chemical reaction may produce cracks in the concrete, thus opening a fault line for further progression of carbonation, and consequently causing the reinforcement to become prone to corrosion. Carbonation does not actually harm the concrete directly nor reduce its strength. However, poor, and porous concrete with high permeability, high water-to-cement ratio, low cement content, short curing period, or poor consolidation makes the concrete susceptible. Its resulting effects on the concrete allow corrosion of the reinforcing steel to thrive.

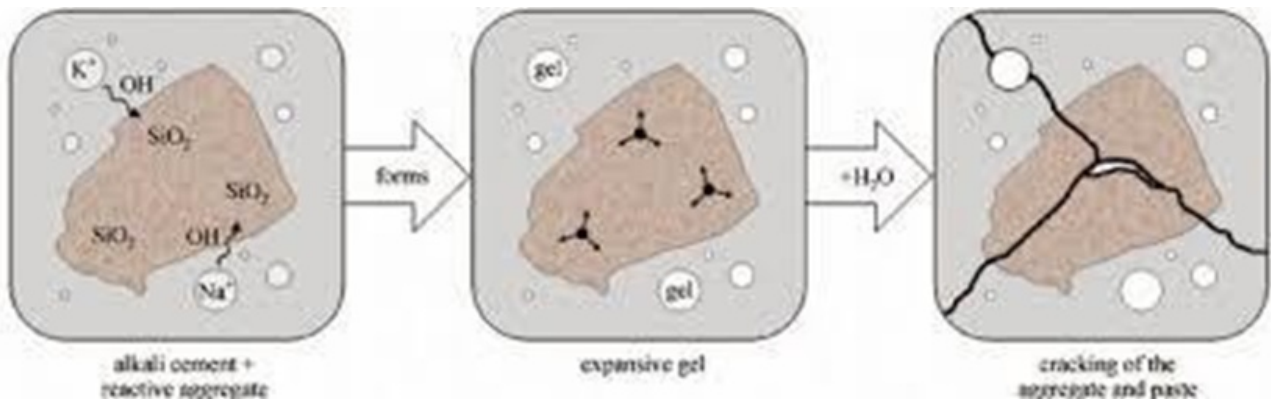
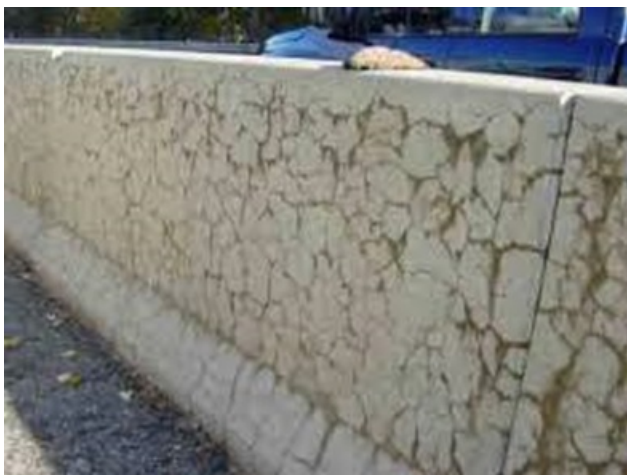
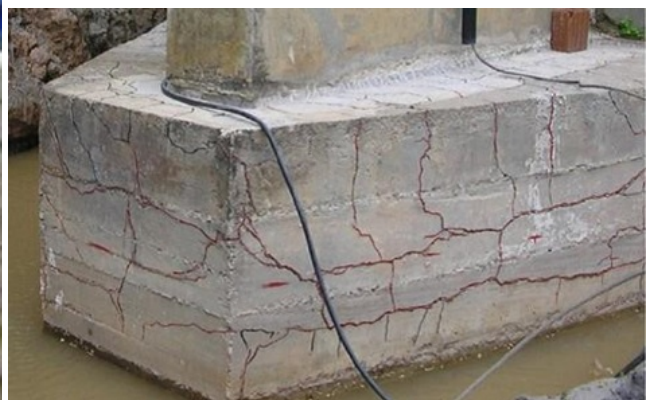
Alkali-Silica Reaction

This chemical attack on concrete durability is as a result of the reaction of the silica in certain aggregate types with the alkaline in cement to produce Alkali-Silica Gel. The expansion of the gel when mixed with moisture leads to cracking and delamination of concrete. Its effect may take about 5 to 10 years to appear.

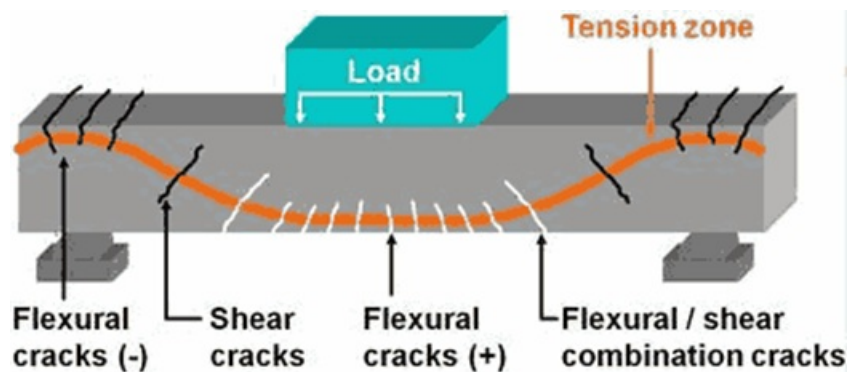
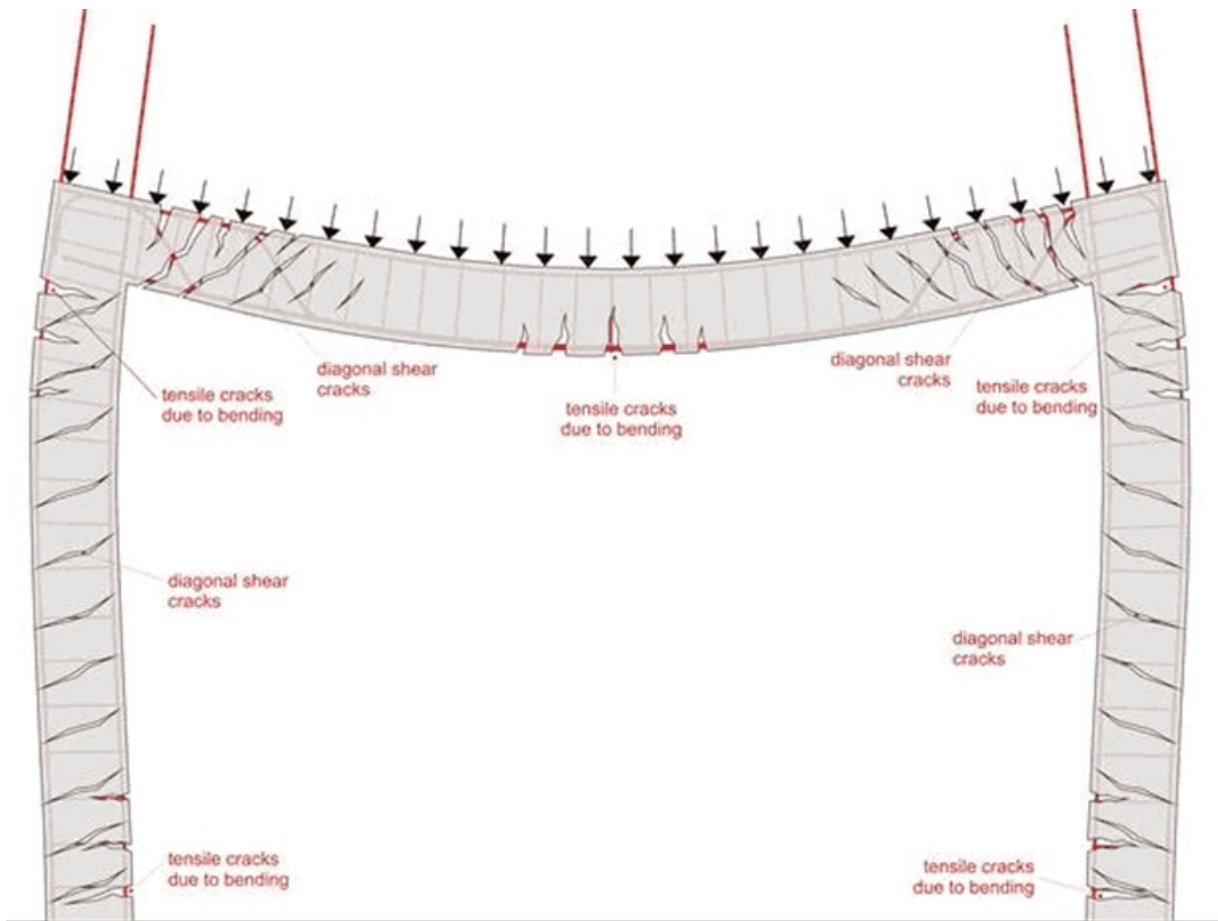
Cracks in concrete

So far, we have seen concrete cracks initiated by environmental conditions resulting in chemical reactions that lead to cracking of concrete. In addition to these, a concrete member can also crack due to overload situations while performing its structural functions. These cracks again expose the reinforcement to corrosion agents and should be eliminated.

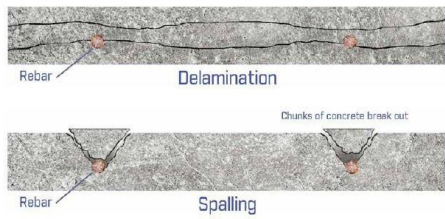
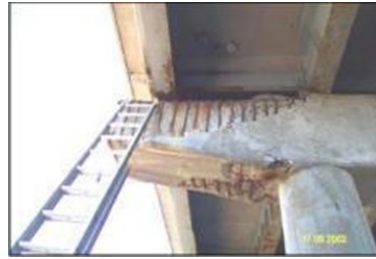
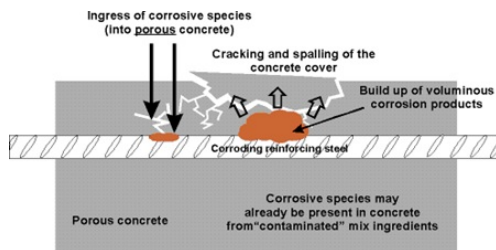
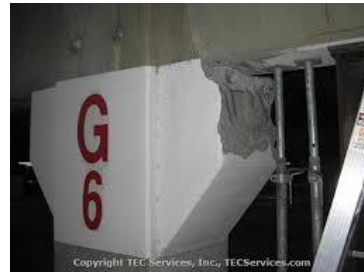
Spalling of Concrete

This can be as a result of the chemical attacks previously mentioned. It can also be due to the expansive action of corroded reinforcement exposed from flexural or shear cracks that develop on the member as a result of overload or due to damage by vehicular or vessel impact forces usually at the exposed corners or edges, deck joints or construction joints. In all cases, spalling is characterized by the actual removal or detachment of chunks of the concrete member. Therefore, there is an appreciable loss of concrete section that must be noted and recorded.

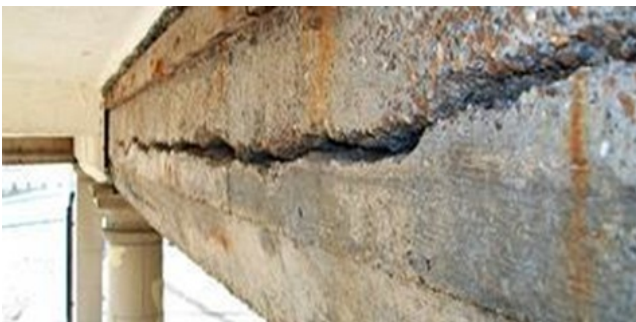
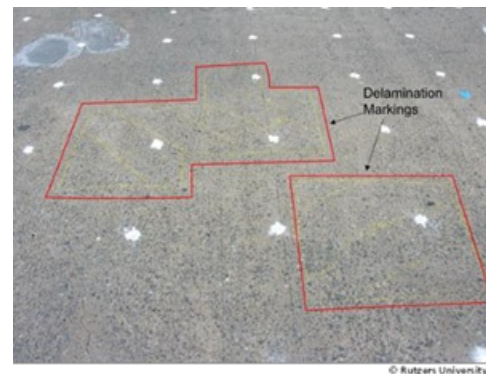
Delamination of concrete

This is a discontinuity in the surface concrete that is substantially separated but not completely detached from the concrete below or above it. It may appear as a solid surface but can be identified by a hollow sound that is produced by tapping the concrete with a hammer. Delamination defects may be hard to detect in the field and should be assessed very carefully.

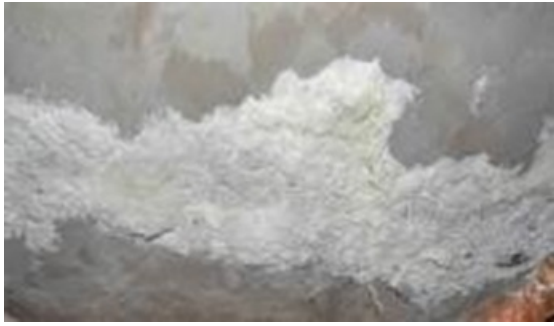
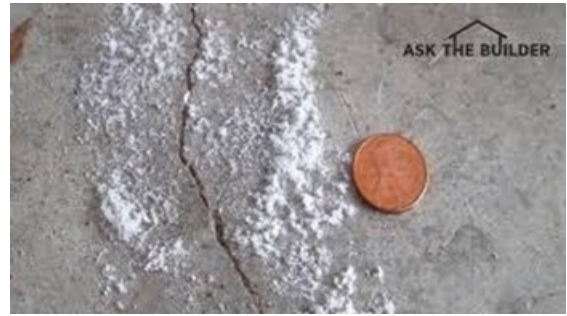
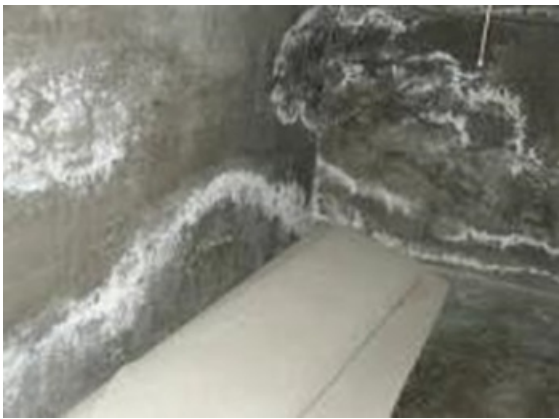
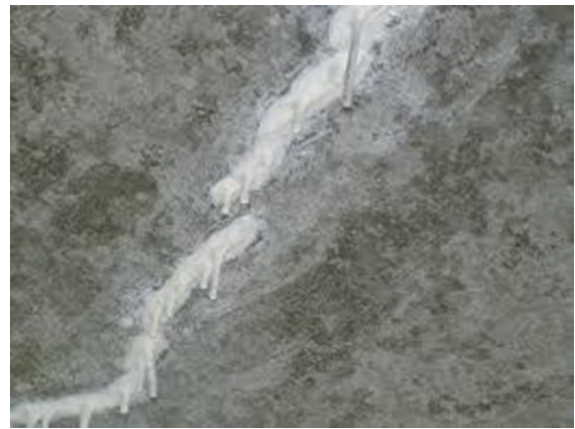
- Concrete Segregation – due to the differential concentration of the components of mixed concrete.
- Cold joints – produced when there is a delay in the placement of successive pours of concrete.
- Surface Deposits:
 - Efflorescence – deposit of salts, usually white and powdery, resulting from a mixture of salt and water that oozes out to the surface through pores or cracks in the concrete.

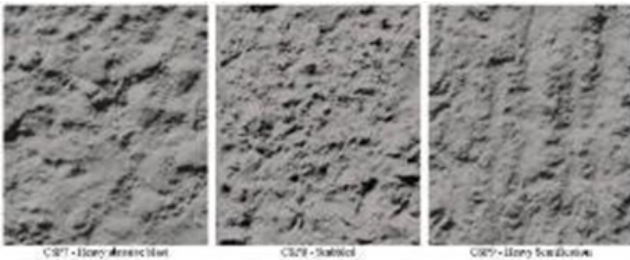
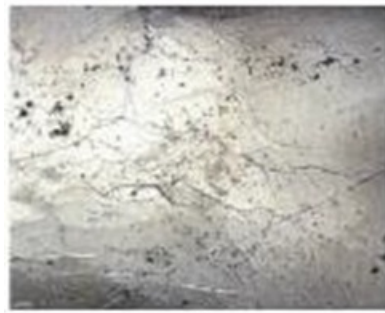
- Exudation – Liquid or gel-like discharge through pores and cracks in the surface.
- Encrustation – A hard crust or coating formed on the concrete surface.

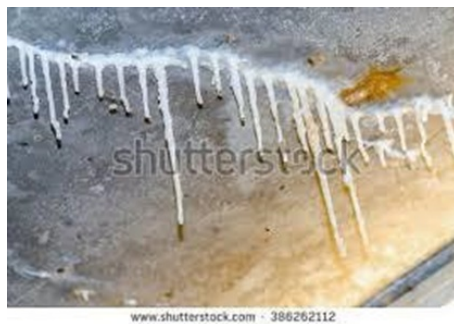
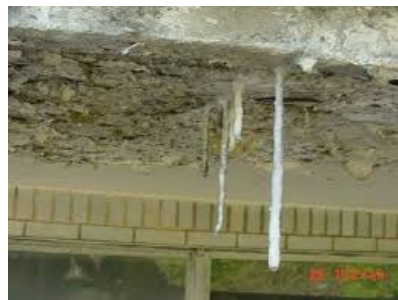
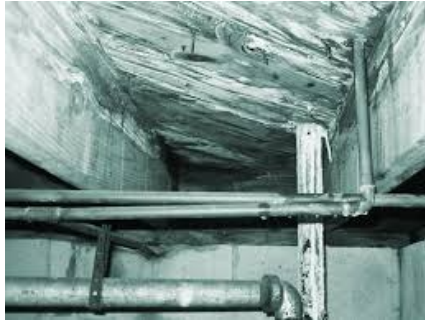
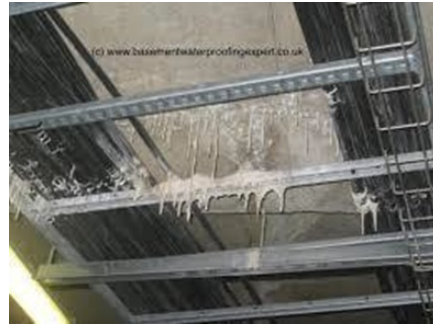
- Stalactite – A downward pointing formation hanging from the concrete surface, usually shaped like an icicle.

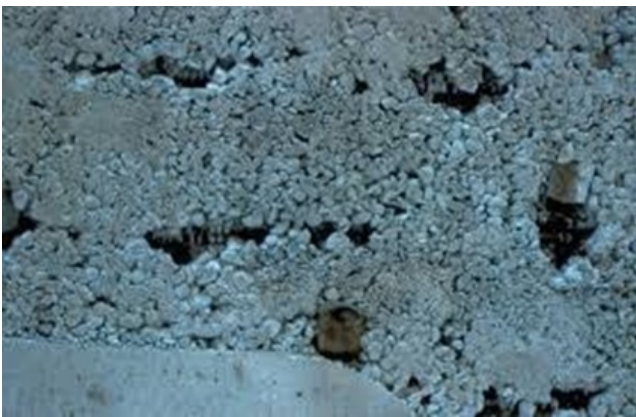
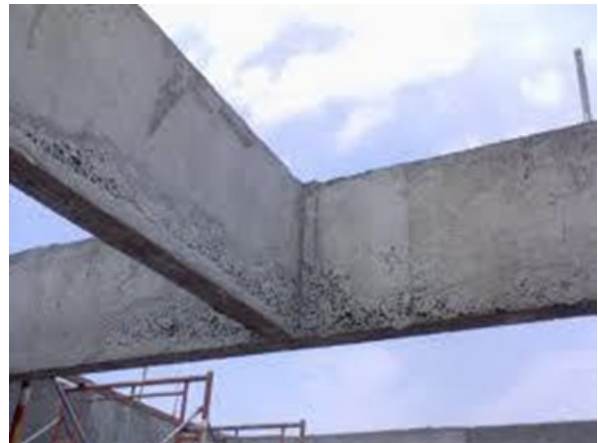
- Honey combing - Produced due to improper or incomplete vibration of the concrete, loss of moisture from formwork during concreting, which results in voids in the concrete. The existence of these voids constitutes a danger to the reinforcement embedded in the concrete member.

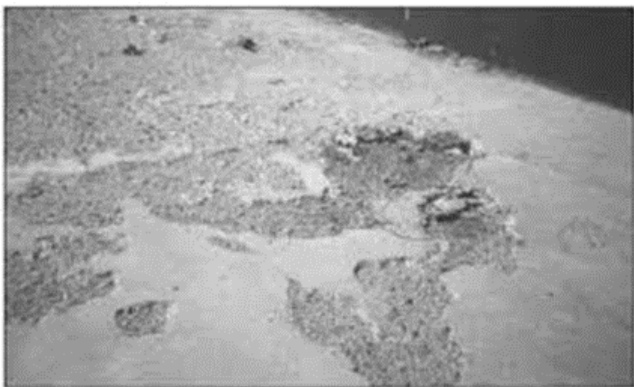
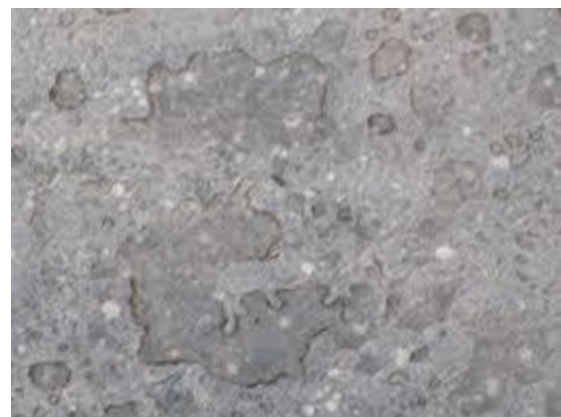
Abrasion

Deterioration of concrete brought about by vehicles scraping against the concrete surfaces, such as the deck, kerbs, barrier walls, and piers.

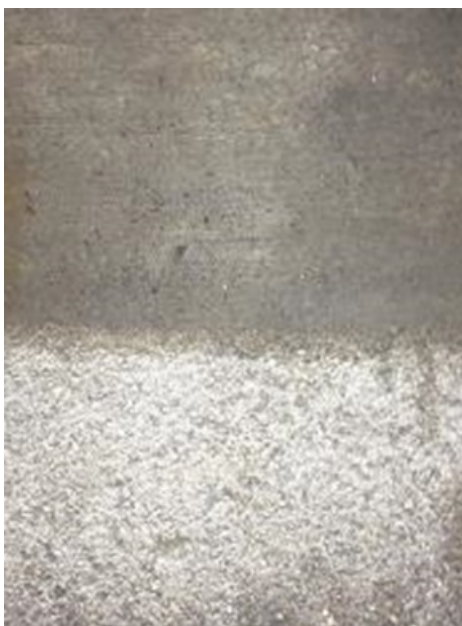
Slippery surface

Results from the polishing of the Conc. Deck surface by the action of repetitive vehicular traffic.

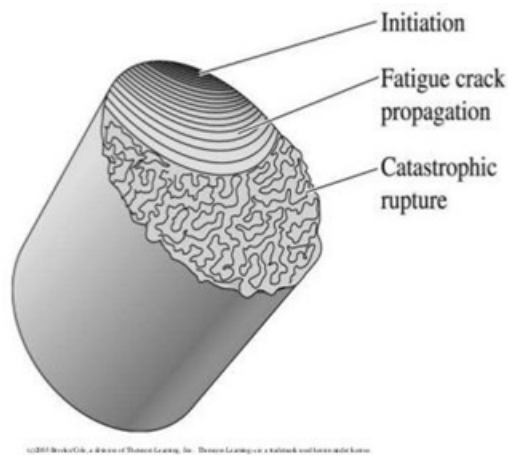
Figure : Schematic representation of a fatigue fracture surface in a steel shaft, showing the initiation region, the propagation of fatigue crack (with beam markings), and catastrophic rupture when the crack length exceeds a critical value at the applied stress

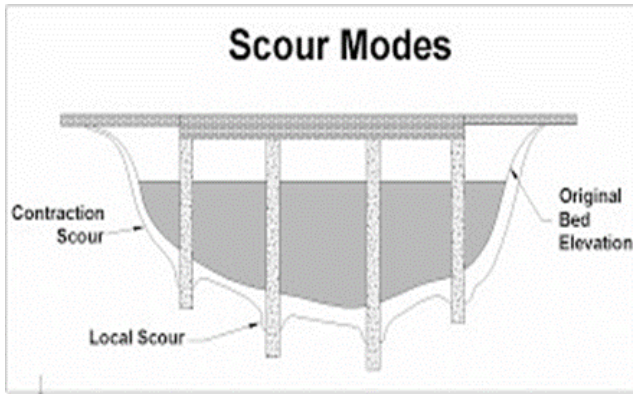
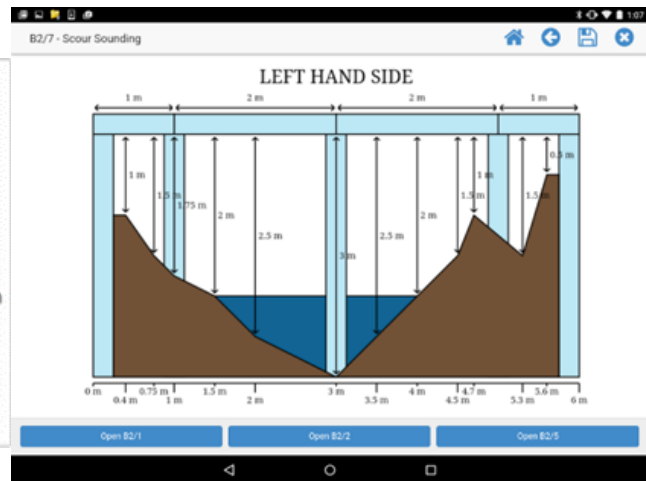
Scouring of Foundation

Scouring of foundation caused by excessive stream flows or changes in the alignment of the stream channel can result in the progressive settlement or movement of abutments and piers and consequently to total bridge collapse if unchecked. Scour is perhaps the biggest threat to the substructure and foundation components regardless of the material the structural component is made of. Exposure of the foundation components and erosion of the surrounding soil strata is a recipe for disaster and poses a serious safety hazard to the structural integrity of the bridge and must be avoided or corrected immediately.

- 1. **General Scour** – Occurs naturally in stream channels and includes the aggradation and degradation of the stream bed, which may occur as a result of changes in the hydraulic parameters governing the channel form such as changes in the flow rate or changes in the quantity of sediment in the river channel.
- 2. **Contraction Scour** – Occurs as a result of the reduction in the channel's cross-sectional area that arises due to the construction of structures such as bridge piers and abutments. It manifests as an increase in flow velocity and the resulting bed shear stresses, thus causing scour.
- 3. **Local Scour** – Occurs around individual bridge piers and abutments.

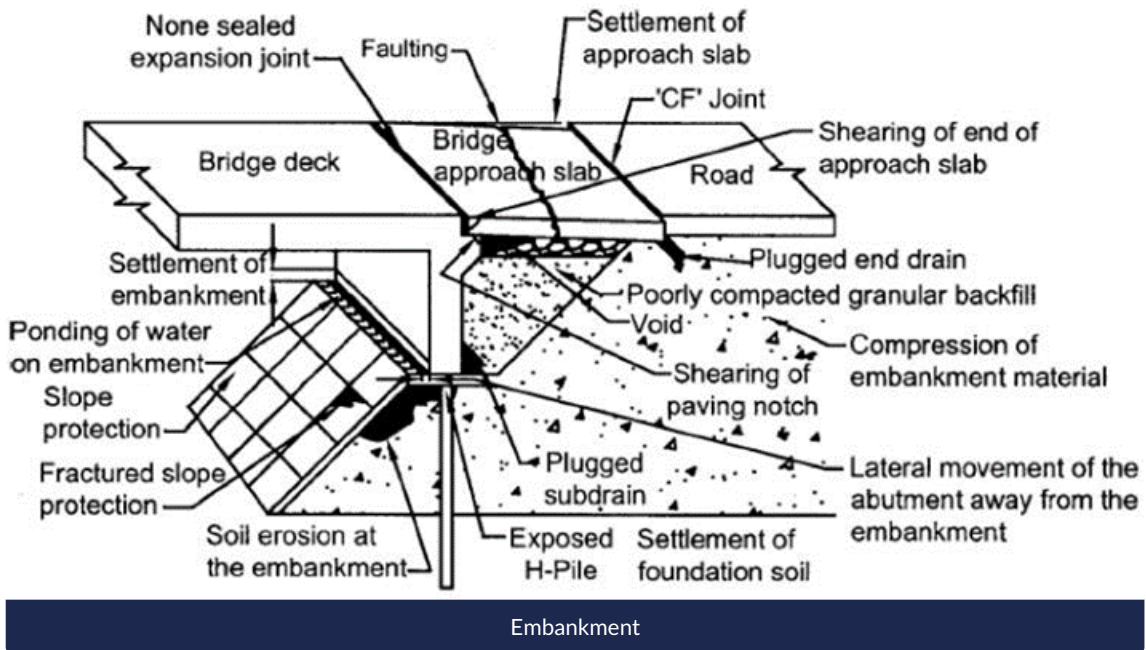
An Embankment is used to provide a stable road between the bridge and the surrounding ground. Often, it is also required for providing horizontal, and sometimes vertical support for the Abutment and foundation. The most common defect associated with the Approach is excessive settlement adjacent to the bridge abutment, which causes unsatisfactory riding quality and possible damage to the deck and expansion joints. Excessive settlement at the bridge approach span interface with the main bridge structure resulting in a “bump” is a safety hazard for the vehicular traffic and its users. Possible reasons for this failure include:

- Poorly compacted embankment
- Continuing settlement of the underlying ground
- Erosion due to blockage or inadequate drainage

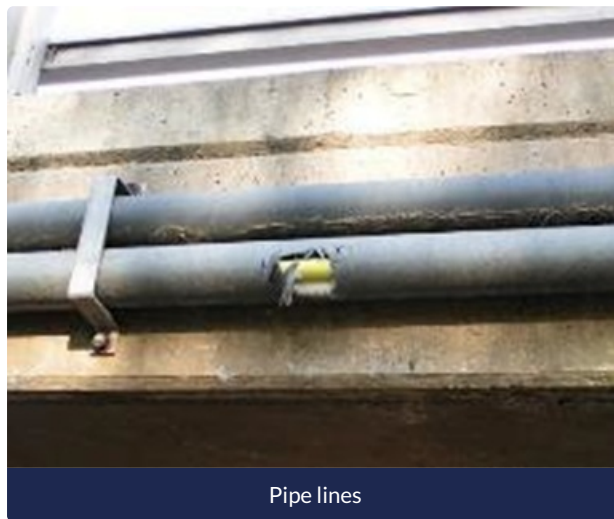
Pipe lines

Utilities, including lightings and pipelines, are often found on bridges and must be inspected for their functional integrity, especially with respect to the bridge structure.
